SMAIC
STATE MARINE ACCIDENT
INVESTIGATION COMMISSION

FINAL REPORT

**of the towing unit: the
tugboat “IKAR” and the
passenger and car river
ferry „SIEBENGEBIRGE”**

Sinking of the ferry under tow in the North Sea on 30 April 2017

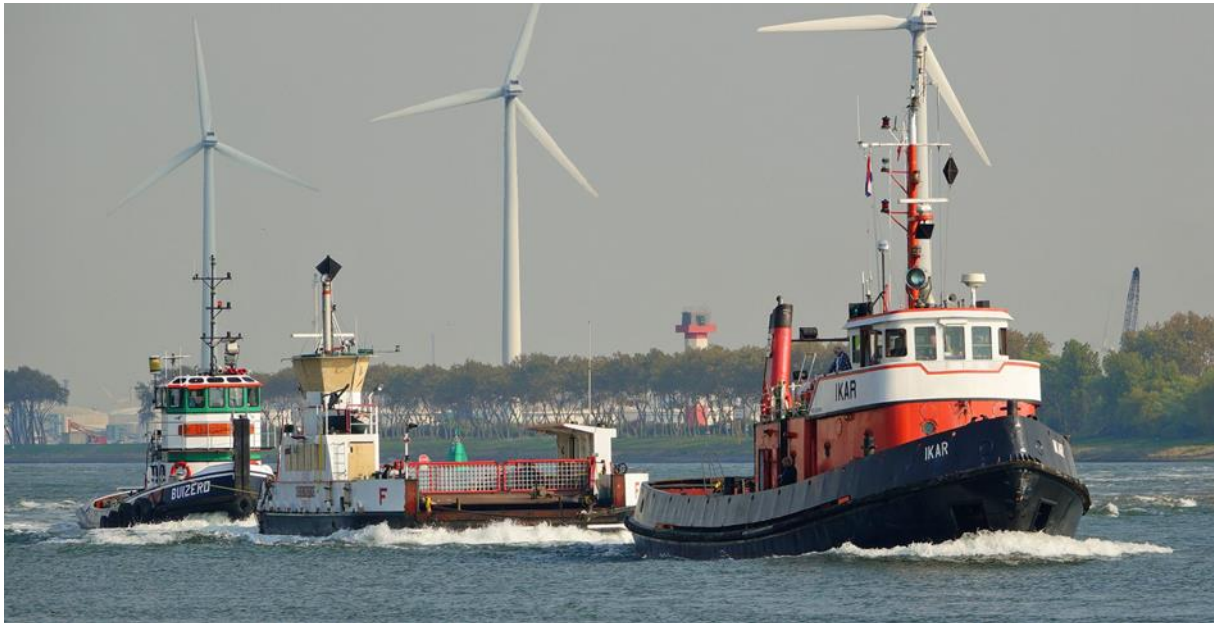
Photograph 4: Towing unit at the exit from Rotterdam with the assistance of a port tugboat. One can see the resisting wave at the ferry's bow

- a. As a result of the lack of tightness water gets into the watertight compartments:
 - i. third watertight compartment - water enters through leaky hatches,
 - ii. first watertight compartment - water gets from the bow through leaky connection of the bow plating,
 - iii. first and third watertight compartment - water gets through the leaky hatches,
 - iv. water enters the first, second and third watertight compartment.
- b. Water enters the deck due to rolling and pitching (Photograph 4).

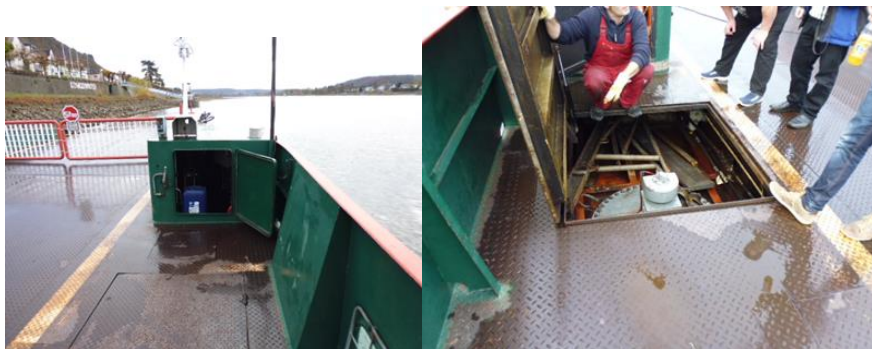
The protection of external openings could only make them splash-proof but it did not prevent water from entering the internal spaces of the ferry through leaks.

Photograph 5: Hatches to the engine compartment – on the starboard bow. Compartment No 3

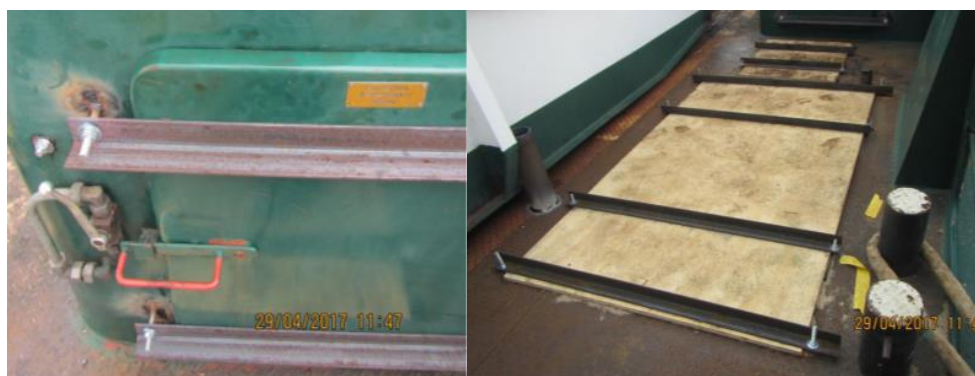
Photograph 6: Hatches to the engine compartment – on the starboard bow. Compartment No 3

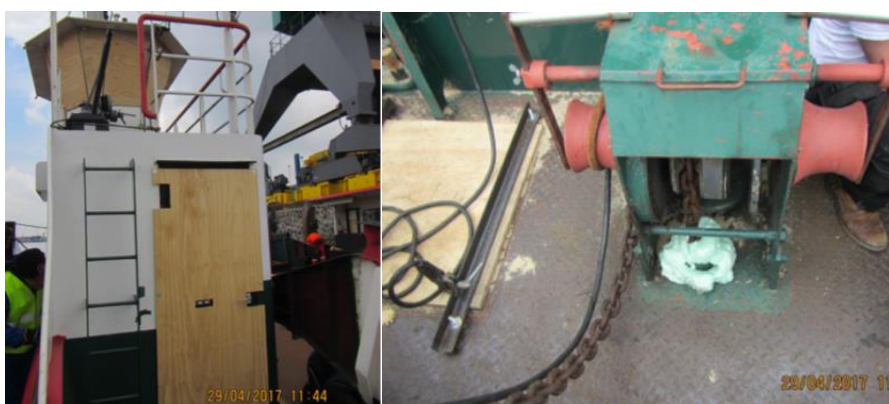
*Photograph 8: Door to the superstructure – starboard. Sealing of the chain pipe.
Compartment No 2*

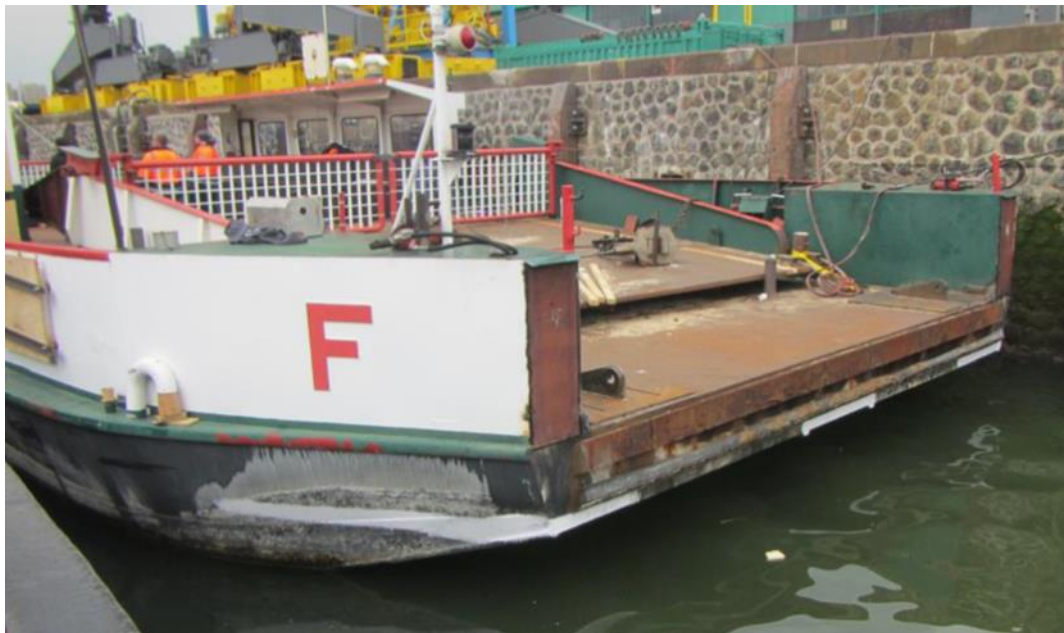
Photograph 9: Ferry's bow, front edge of the compartment No 1

- Flooding the deck with water (33 t) without unsealing the closures could not have led to capsizing of the ferry (Condition 2).
- Water could have also got through the leaky part of the bow at the point of dismantling the platform. The wave created on the bow during towing and additionally wavy motion of the sea could have resulted in the bow getting into water, which could have caused flooding of the watertight compartment No 1.

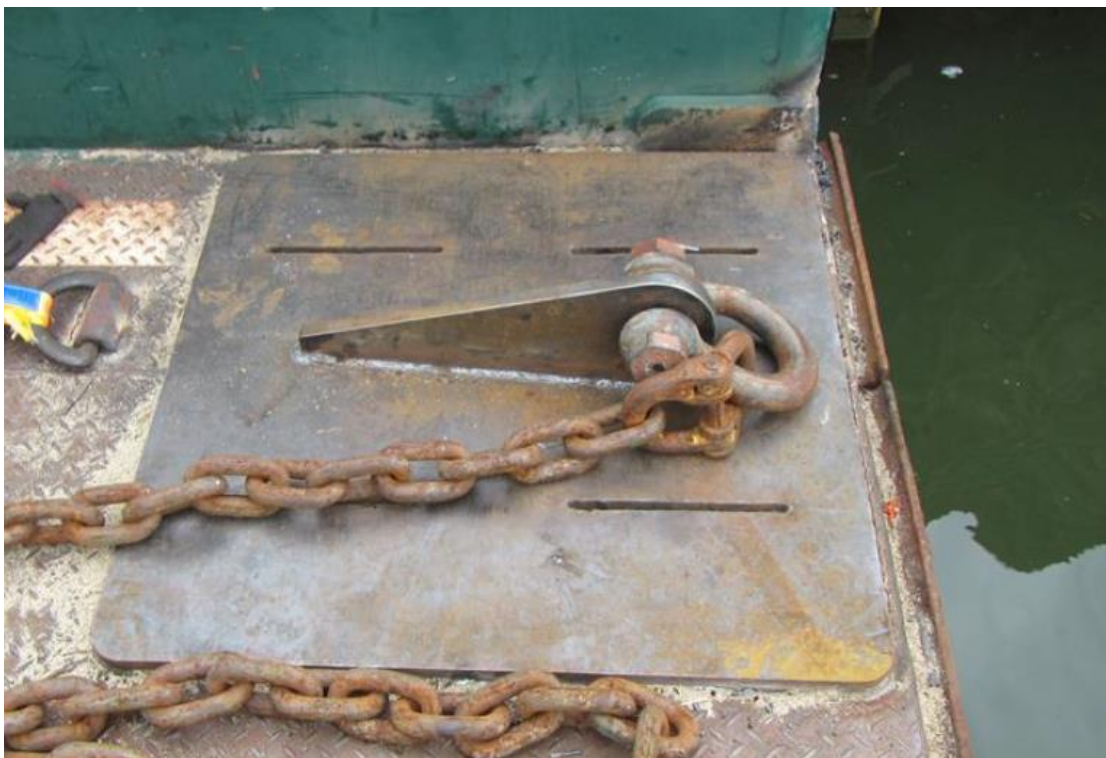
Photograph 10: The chain bridle installed on the port side bow of „Siebengebirge” with the chain (the photograph taken by the representative of the insurer)

The Redwise company welded the bridles to the deck plating of the ferry at starboard and port side of the bow. Technical documentation or strength calculation of bridles has not been preserved. According to the information obtained from the master of *MT Ikar* such documentation had not been presented. Due to the lack of calculations, the representative of the insurer required carrying out load test from the master of *MT Ikar*. Each of the bridles was loaded with force of 19 tons acting almost horizontally. According to the information provided by the master of *MT Ikar*, the crew members who were at the tugboat's stern during the tests noticed that the deck of the ferry where the bridles were welded on was working hard (raising). When the tests were completed no damage on the deck was noticed, however, the inside of the pontoon was not inspected for any damage caused by the tests.

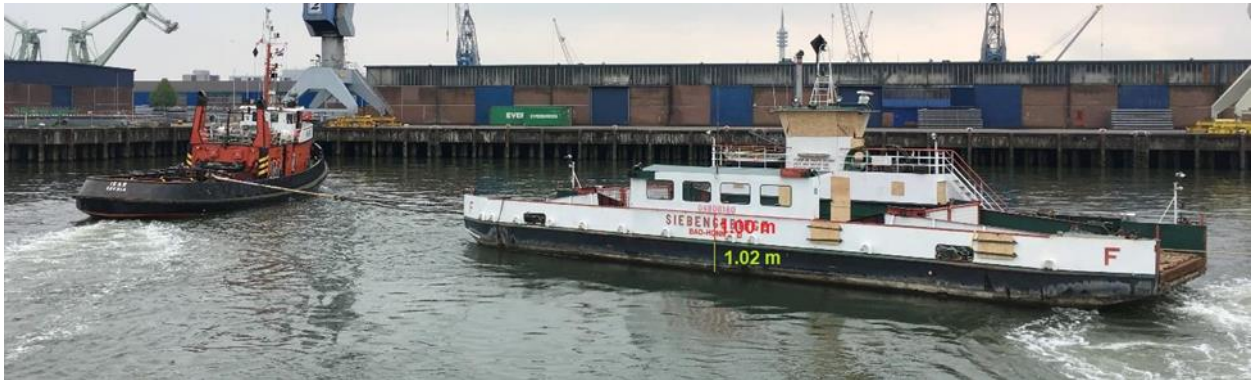
Photograph 11: Ferry's freeboard: $FB = 1.02\text{ m}$

- From the observation of the photographs of the ferry leaving the port of Rotterdam, it appears that the freeboard amidships was about 1.02 m, so the ferry's immersion was 0.83 m. That was much less than the 1.0 m read by the master of *Ikar*.
- No draught marks can be seen in any of the photographs obtained from the Al Mare Consulting AB company's report.
- This corresponds to the displacement of the ferry from the Stability Book. The weight of the empty ferry was 78 t as it results from stability tests, assuming a fuel weight of approx. 1.2 t, and the protective materials and the ship's constant of about 2 tons. Totally we get the weight of 81.2 t, which corresponds to the draught of 0.79 m in fresh water.

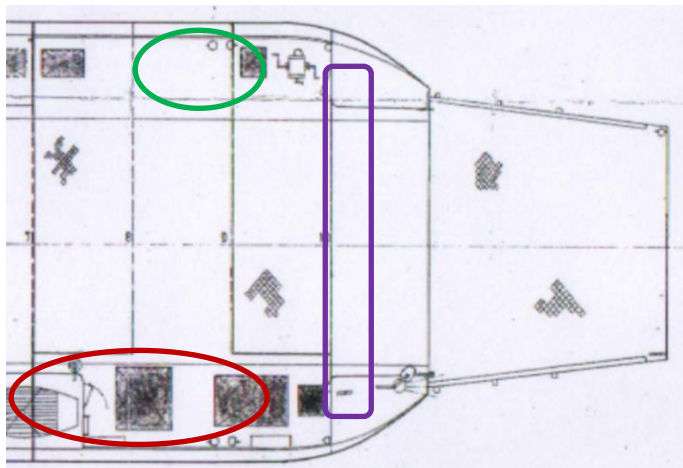
- water getting on the ferry's fore deck and staying for a certain period of time (there were only two drain holes on each side where the mooring bollards were located).
- Water entering the foremost watertight compartments No 1, 2 and 3 through on-board seals or/and through a leak in the bow.
- Protection made at the port of Rotterdam secured the closing devices against opening, but it did not increase the tightness of the secured hatches and doors.
- Water entering the compartment No 3 would cause trim by the head and heel on starboard side.

Figure 7: Hatches to the watertight compartment No 3 (red), No 2 (green) and the platform with the deck at the edge of the compartment No 1 (purple)

- When flooding the foresection of the deck, water could have entered the bow watertight compartments Nos 1, 2 and 3 (see Fig. 8).
- Flooding of a single watertight compartment No 1 or No 3, including water on deck, could not have led to capsizing of the ferry (Condition 3/1 and Condition 3/2).

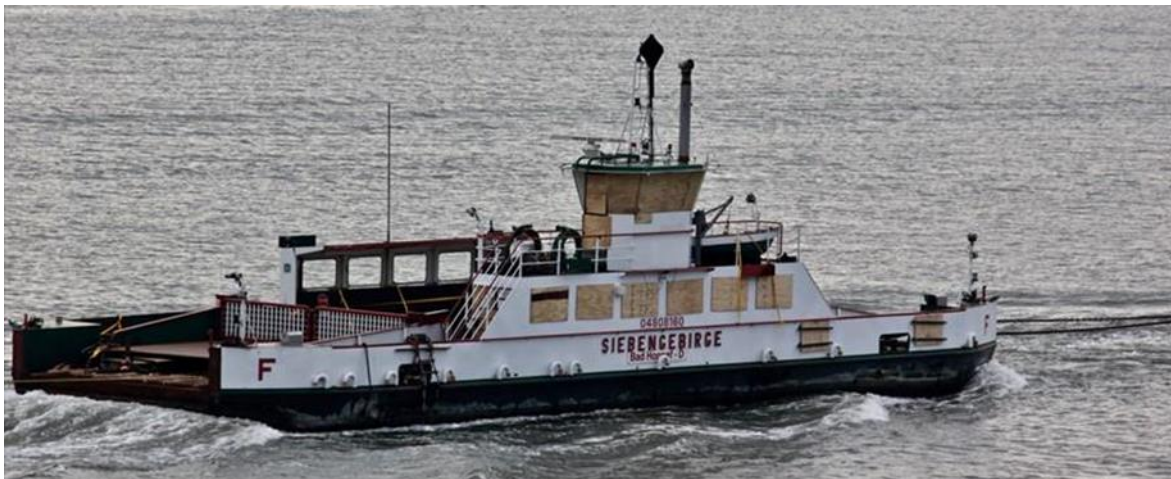
Photograph 12: The „Siebengebirge“ ferry under tow. One can see the starboard

- As the tugboat crew observed, the ferry had an increased draught on the bow and tilt on starboard side, which means that originally the unsymmetrical compartment No 3 (Condition 3/2) had been flooded.

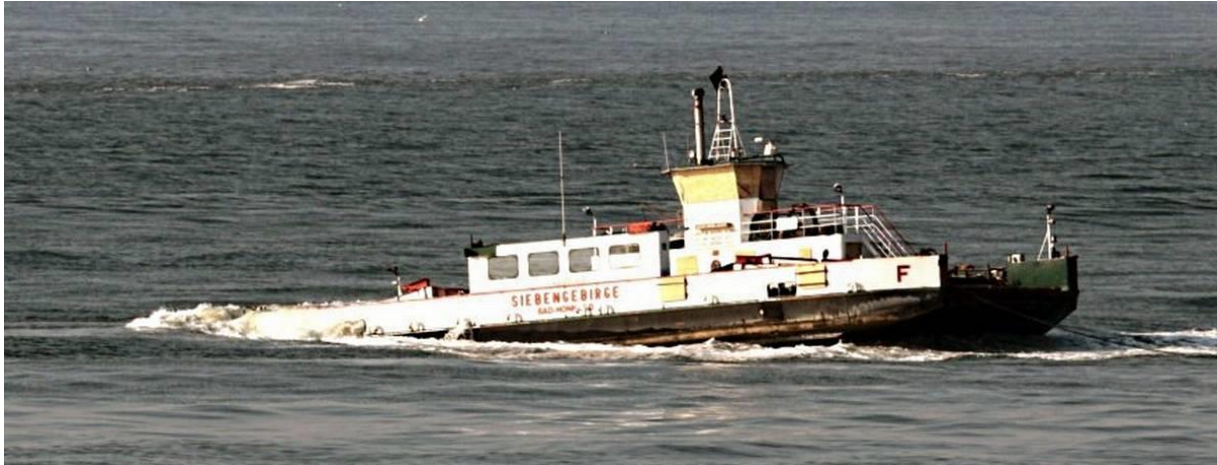
Photograph 13: The „Siebengebirge” ferry with the bow under water. The photograph presents the stern – portside of the ferry. One can see the outflow of water from the deck (<http://www.general-anzeiger-bonn.de>)

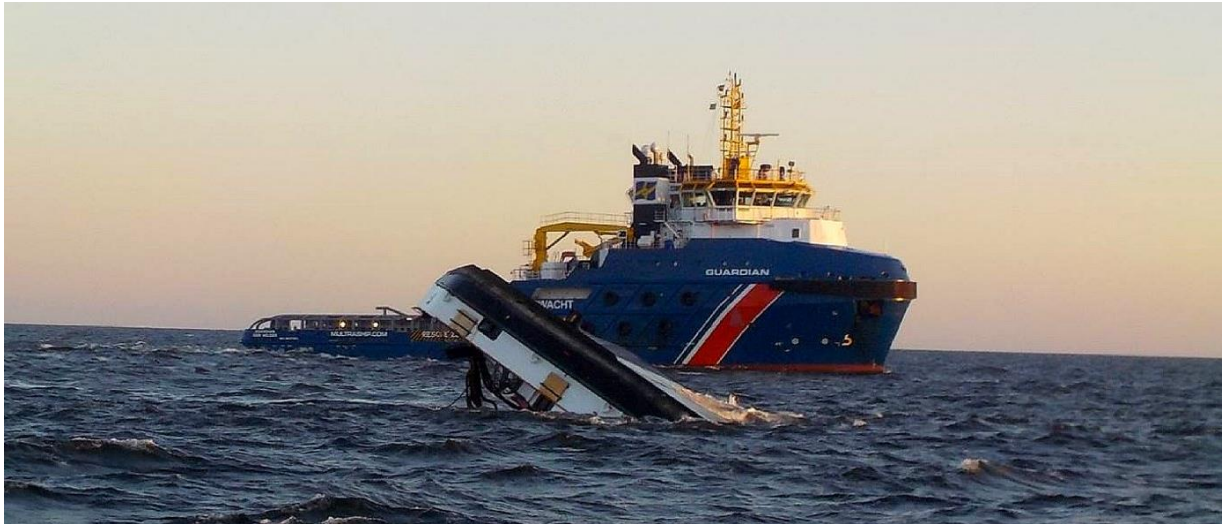
*Photograph 14: Capsized „Siebengebirge”. One can see the stern and portside of the ferry
([http:// www.eyes.org/news/sos_1704.html](http://www.eyes.org/news/sos_1704.html))*

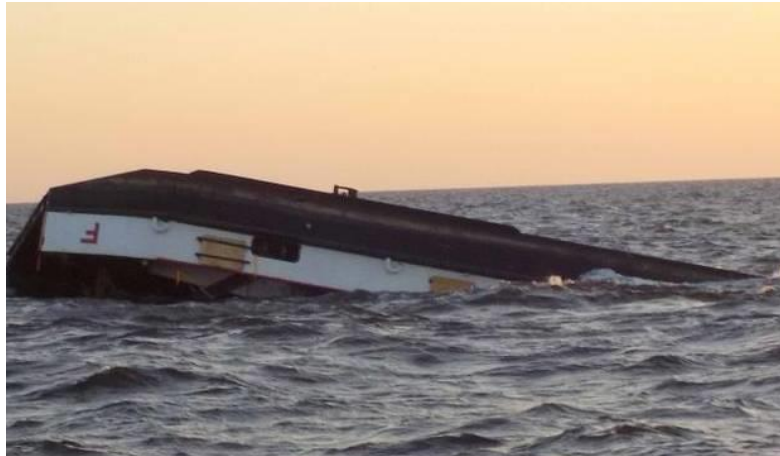
Photograph 15: Capsized „Siebengebirge”. One can see the stern and portside of the ferry
(http://www.eyes.org/news/sos_1704.html)

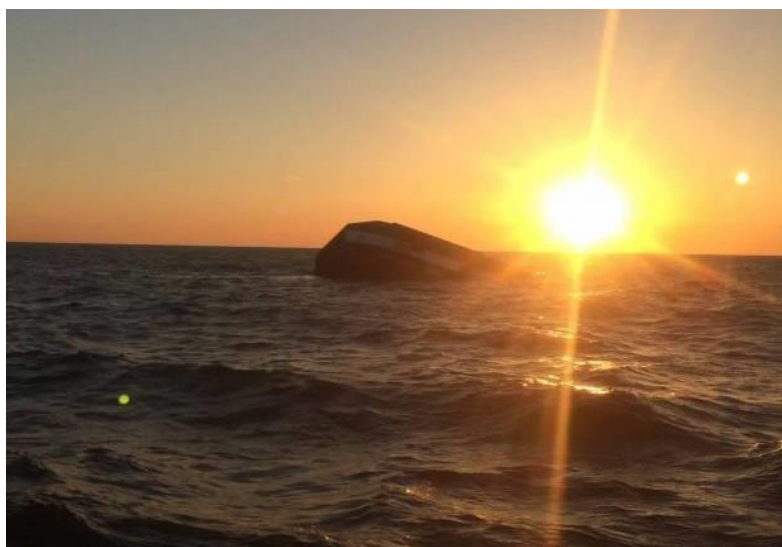
Photograph 16: Capsized „Siebengebirge”. One can see the stern and portside of the ferry
(<http://general-anzeiger-bonn.de>)
