SMAIC
STATE MARINE ACCIDENT
INVESTIGATION COMMISSION

FINAL REPORT

**of the towing unit: the
tugboat “IKAR” and the
passenger and car river
ferry „SIEBENGEBIRGE”**

Sinking of the ferry under tow in the North Sea on 30 April 2017

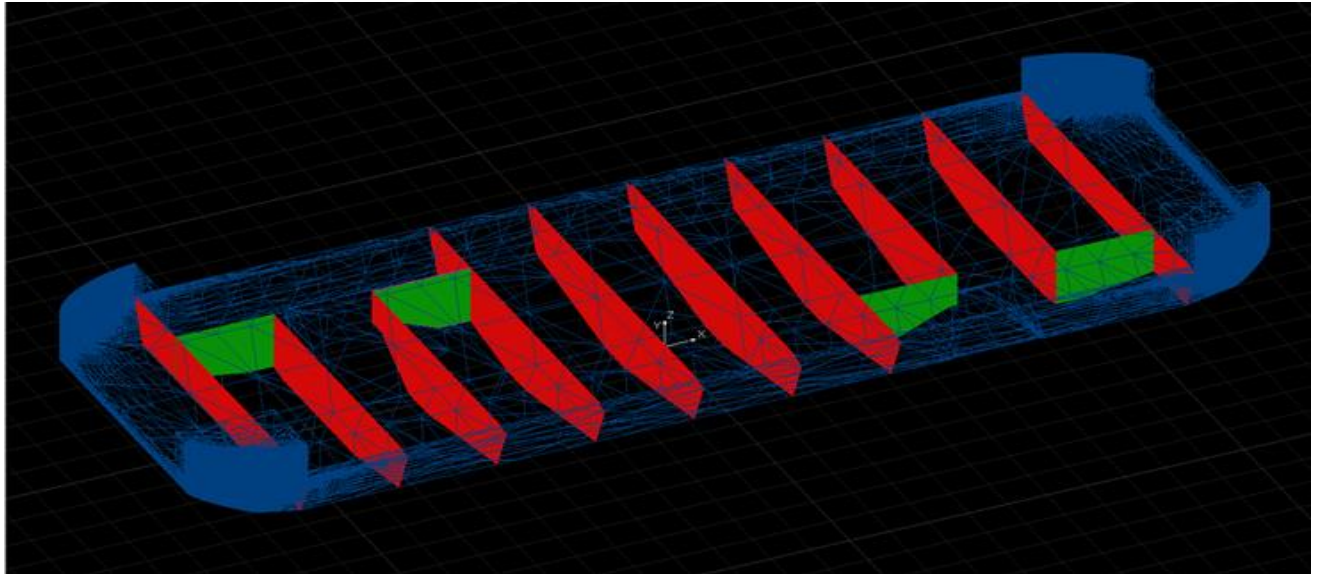
Figure 5: Hatchways on board and watertight compartments of the „Siebengebirge” ferry

- When flooding the foresection of the deck, water could have entered the bow watertight compartments Nos 1, 2 and 3 (see Fig. 8).
- Flooding of a single watertight compartment No 1 or No 3, including water on deck, could not have led to capsizing of the ferry (Condition 3/1 and Condition 3/2).

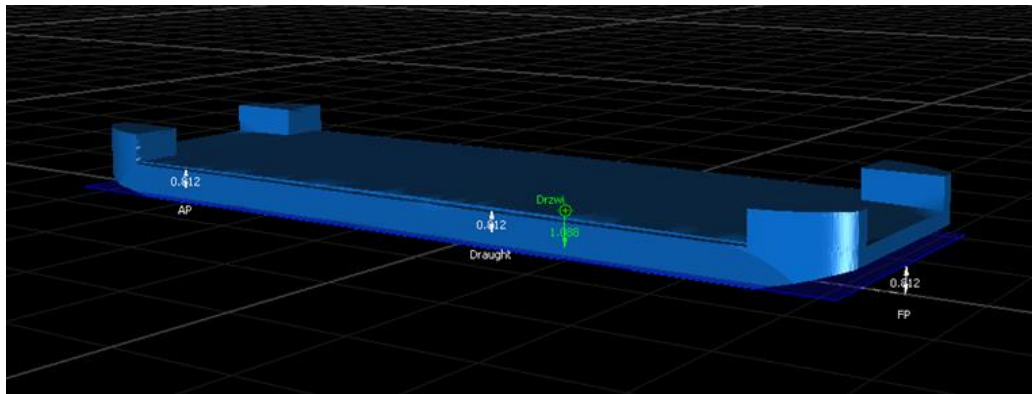
Figure 9: Position of the ferry in Condition 1

1	Mean draught	T	0.81	m
2	Trim	t	0.00	m
3	Draught on FP	TF	0.81	m
4	Draught on AP	TA	0.81	m
5	Freeboard	FB	1.04	m
6	Vertical center of gravity	z _G	1.91	m
7	Free surface correction	ΔGM	0.00	m
8	Vertical center of gravity corrected for free surf.	z _{G'}	1.91	m
9	Metacentric height	GM'	12.93	m
10	Ferry list	φ	0.0	°

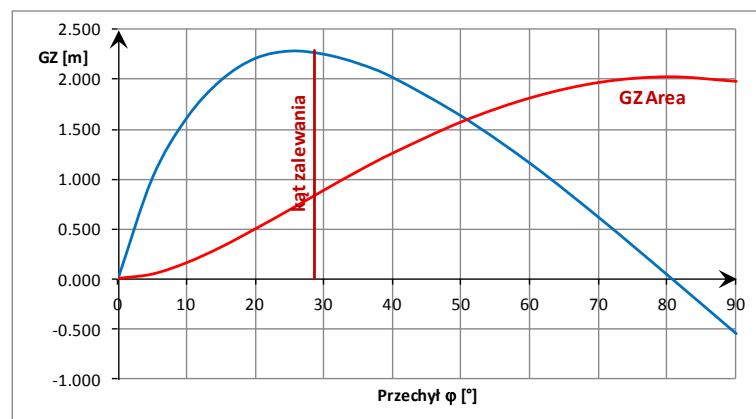
Figure 10: The diagram of righting arms

Angle of tilt φ [°]	GZ [m]	Work of GZ [m·rad]
0	0.000	0.000
5	1.012	0.044
10	1.614	0.159
15	1.994	0.316
20	2.213	0.500
25	2.286	0.696
30	2.252	0.894
35	2.158	1.087
40	2.013	1.269
50	1.618	1.586
60	1.136	1.826
70	0.596	1.977
80	0.023	2.031

The *Siebengebirge* ferry as an inland navigation vessel was not obliged to fulfill the stability criteria for sea-going vessels.

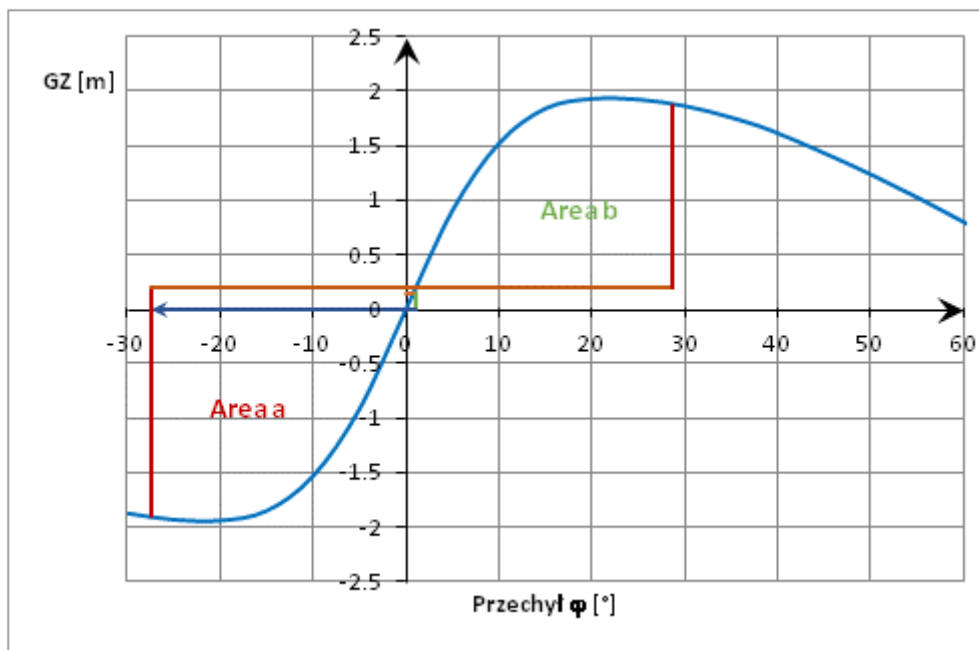
Figure 11: Weather criterion

No	Description	Required values	Achieved values	Criterion
1.	Area under the righting arms curve GZ, from 0° to 30°,	0.055 m·rad	0.815 m·rad	Fulfilled
2.	Area area under the righting arms curve GZ, from 0° to 40° (or the angle of flooding = 28°),	0.090 m·rad	0.815 m·rad	Fulfilled
3	Area under the righting arms curve GZ, from 30° to 40°(or the angle of flooding),	0.030 m·rad	Angle of flooding of 30° or more	Unfulfilled
4	For the angle of 30° or more, the righting arm GZ should be greater or equal to 0.20 m	0.20 m	2.252 m	Fulfilled
5	Maximum righting arm should appear for the angle not smaller than 15° for vessels where $B/T \geq 2.5$	15°	25°	Fulfilled
	Surface area under the righting arms curve GZ, from 0° to $\varphi(GZ_{MAX})$,	0.065 m·rad	0.738 m·rad	Fulfilled
6	Corrected metacentric height GM' should be higher than 0.15 m	0.15 m	12.93 m	Fulfilled
7	Weather criterion: area b should not be smaller than area a: $b \geq a$ $L_{w1} = 0.133$ m $L_{w2} = 0.199$ m $\varphi_1 = 28.8^\circ$	$b \geq a$	$a = 0.889$ m·rad $b = 0.776$ m·rad	Unfulfilled

- The *Siebengebirge* ferry does not meet general criteria of the Stability Code IS2008.
- The criterion related to minimum work of the ferry's roll between 30° and 40° and the weather criterion developed for heavy seas are not met.
- Despite of the above, due to its stability, the ferry should be able to survive safely the voyage in existing weather conditions.

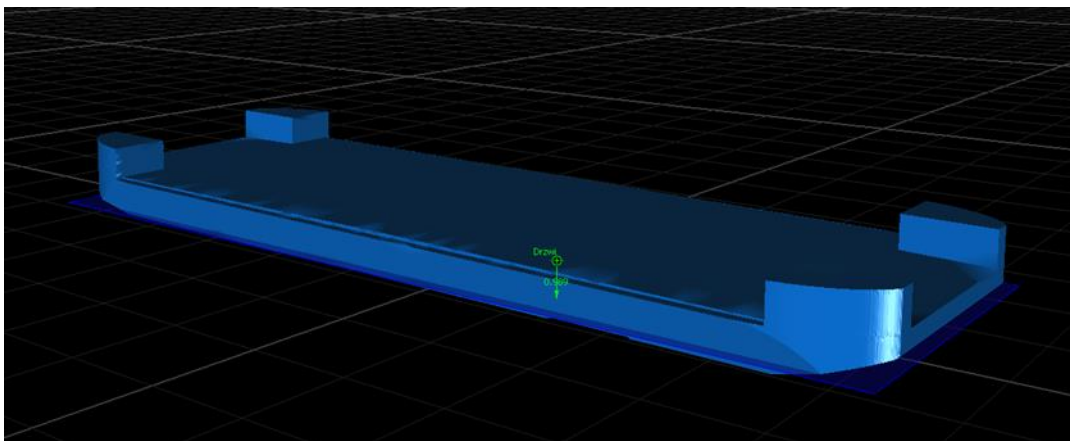
Figure 12: Position of the ferry in Condition 2

1	Mean draught	T	0.87	m
2	Trim	t	0.23	m
3	Draught on FP	TF	0.98	m
4	Draught on AP	TA	0.86	m
5	Freeboard	FB	0.87	m
6	Vertical center of gravity	z_G	1.93	m
7	Free surface correction	ΔGM	5.91	m
8	Vertical center of gravity corrected for free surf.	$z_{G'}$	8.07	m
9	Metacentric height	GM'	5.52	m
10	Ferry list	φ	0.0	°

- Due to water getting in the deck in the foresection, the metacentric height is diminished to 5.52 m, maximum righting arm diminishes to 0.48 m for 10° angle, whereas the range of righting arms diminishes to 20°.
- Despite the diminishment of the stability parameters, the ferry does not capsize in the weather conditions during towage.

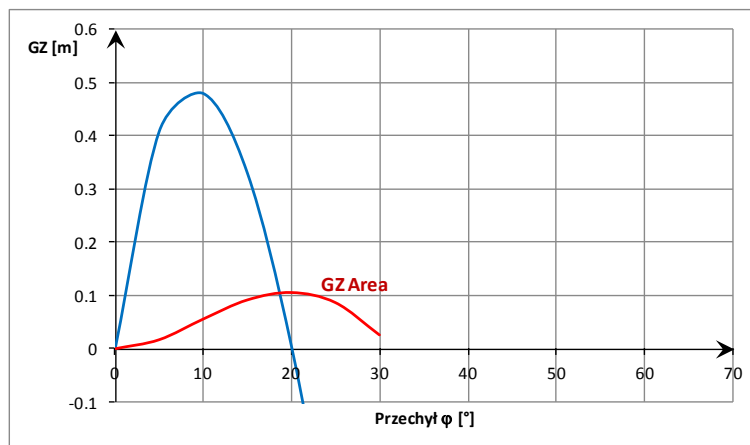
Figure 13: The diagram of righting arms

Angle of heel φ [°]	GZ [m]	Work of GZ [m·rad]
0	0.000	0.000
5	0.409	0.017
10	0.480	0.056
15	0.330	0.092
20	0.004	0.106
25	-0.443	0.087
30	-0.957	0.026
35	-1.508	
40	-2.077	
50	-3.226	
60	-4.315	
70	-5.284	
80	-6.097

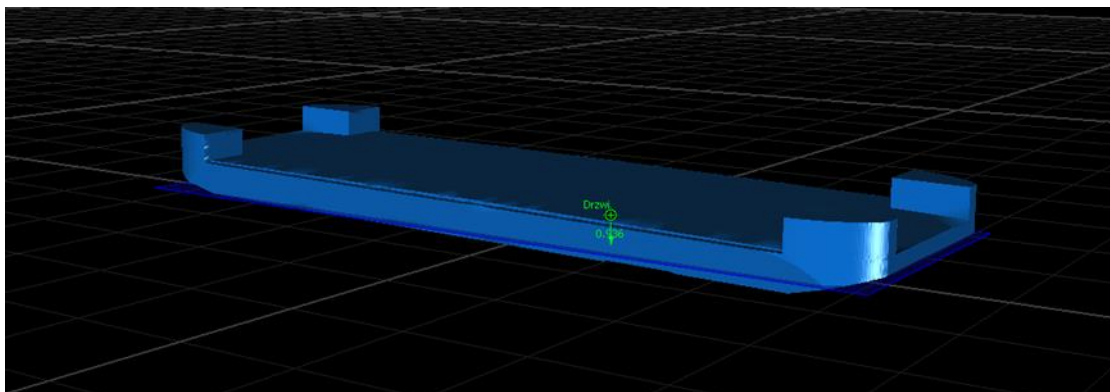
Figure 14: Position of the ferry in Condition 3/1

1	Mean draught	T	0.87	m
2	Trim	t	0.47	m
3	Draught on FP	TF	1.11	m
4	Draught on AP	TA	0.64	m
5	Vertical center of gravity	z_G	1.81	m
6	Free surface correction	ΔGM	1.22	m
7	Vertical center of gravity corrected for free surf.	$z_{G'}$	3.02	m
8	Metacentric height	GM'	10.33	m
9	Ferry list	φ	0.0	°

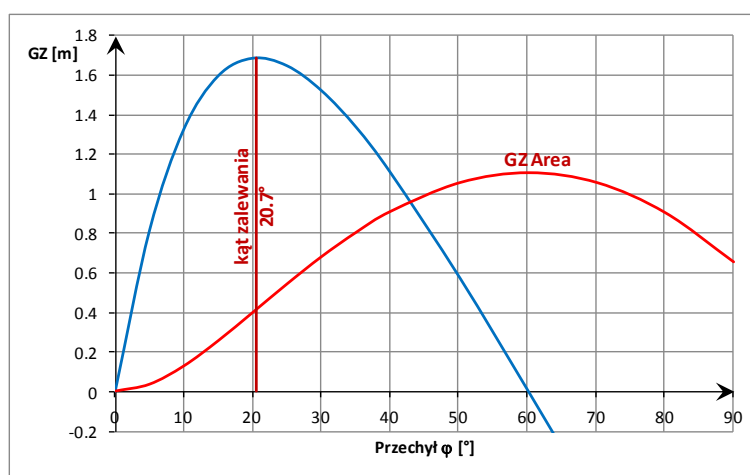
Figure 15: The diagram of righting arms

Angle of heel φ [°]	GZ [m]	Work of GZ [m·rad]
0	0.000	0.000
5	0.814	0.035
10	1.326	0.128
15	1.595	0.256
20	1.684	0.399
25	1.646	0.544
30	1.521	0.682
35	1.334	0.807
40	1.104	0.913
50	0.572	1.059
60	-0.003	1.109
70	-0.587	1.058
80	-1.158	0.905

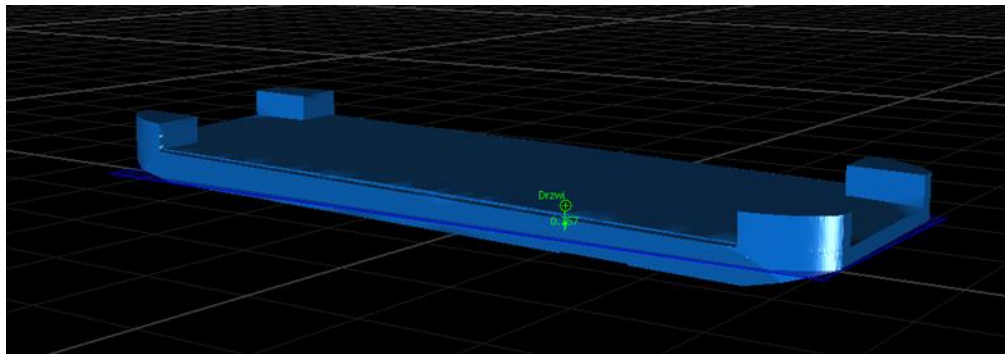
Figure 16: Position of the ferry in Condition 3/2

1	Mean draught	T	0.94	m
2	Trim	t	0.62	m
3	Draught on FP	TF	1.25	m
4	Draught on AP	TA	0.63	m
5	Vertical center of gravity	z_G	1.61	m
6	Free surface correction	ΔGM	1.60	m
7	Vertical center of gravity corrected for free surf.	$z_{G'}$	3.21	m
8	Metacentric height	GM'	8.78	m
9	Ferry list	φ	1.4	°

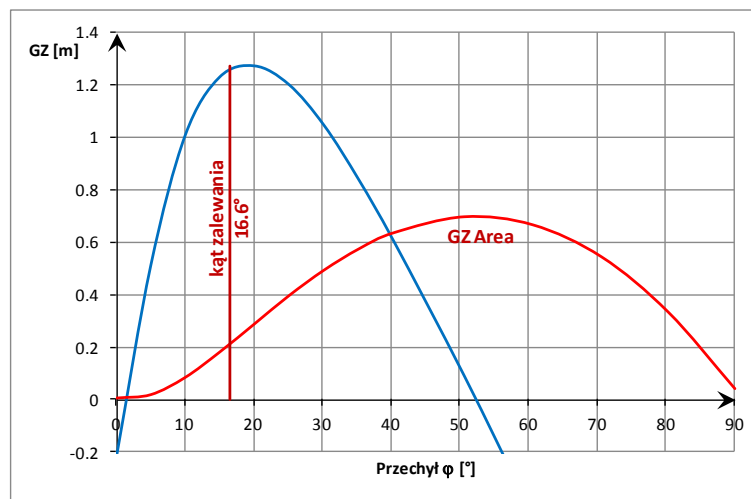
Figure 17: The diagram of righting arms

Angle of heel φ [°]	GZ [m]	Work of GZ [m·rad]
0	-0.220	0.003
5	0.510	0.016
10	1.005	0.082
15	1.227	0.179
20	1.270	0.288
25	1.199	0.396
30	1.044	0.494
35	0.835	0.576
40	0.600	0.638
50	0.090	0.699
60	-0.442	0.668
70	-0.965	0.545
80	-1.461	0.333

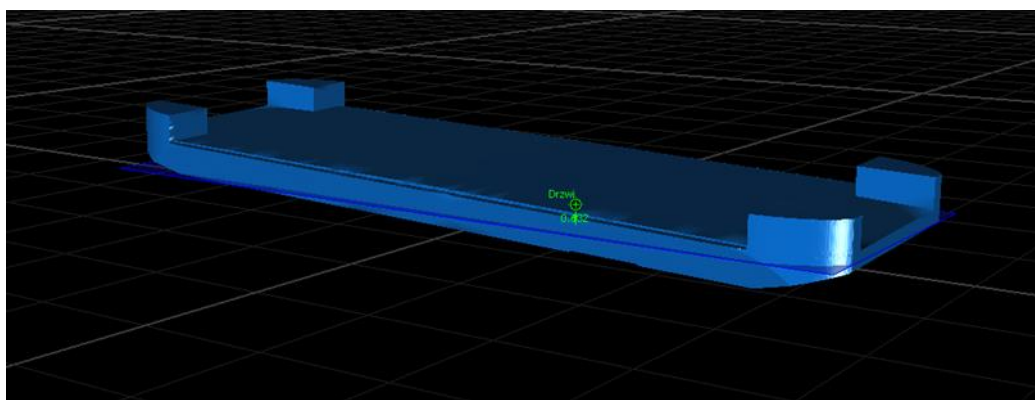
Figure 18: Position of the ferry in Condition 3/3

1	Mean draught	T	0.99	m
2	Trim	t	1.01	m
3	Draught on FP	TF	1.49	m
4	Draught on AP	TA	1.08	m
5	Vertical center of gravity	z_G	1.57	m
6	Free surface correction	ΔGM	2.35	m
7	Vertical center of gravity corrected for free surf.	$z_{G'}$	3.92	m
8	Metacentric height	GM'	7.68	m
9	Ferry list	φ	1.6	°

- Due to flooding of compartments Nos 1 and 3 up to the height of 1.50 m, the ferry does not capsize.
- Ferry floats with 1.8° tilt on the starboard side.
- Foresection deck does not go into water.

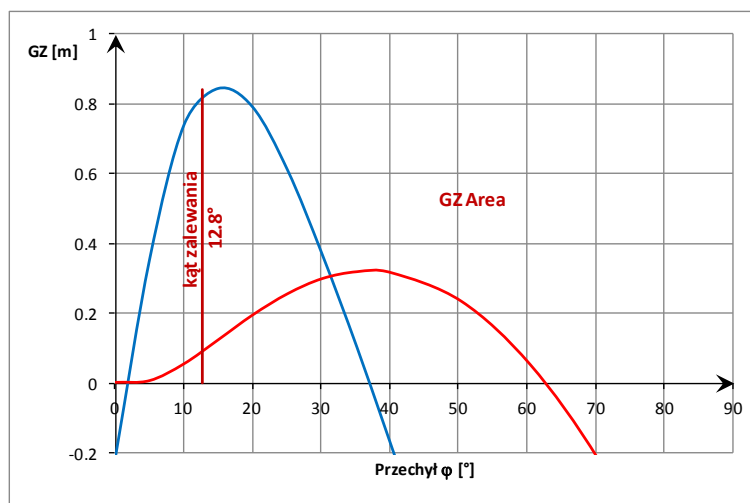
Angle of heel ϕ [°]	GZ [m]	Work of GZ [m·rad]
0	-0.217	0.004
5	0.352	0.009
10	0.737	0.057
15	0.842	0.126
20	0.789	0.197
25	0.608	0.258
30	0.369	0.301
35	0.101	0.321
40	-0.181	0.318
50	-0.757	0.236
60	-1.314	0.055
70	-1.824	-0.219
80	-2.276

Figure 19: The diagram of righting arms
Conclusions:

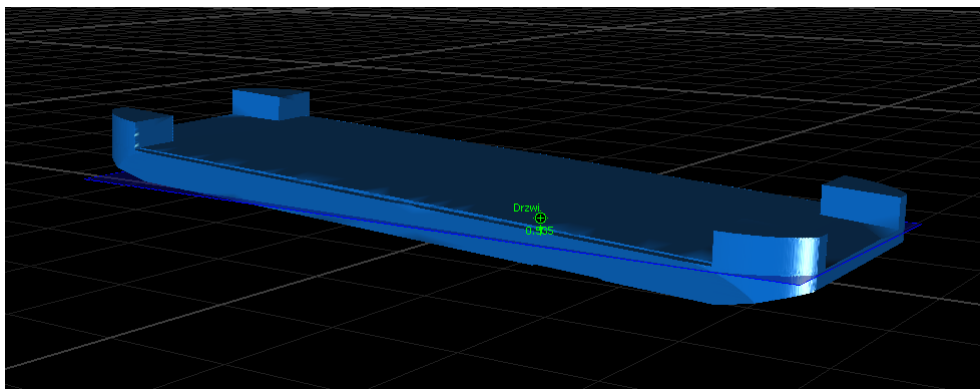
Figure 19: Righting arms and work of GZ

1	Mean draught	T	1.04	m
2	Trim	t	1.41	m
3	Draught on FP	TF	1.75	m
4	Draught on AP	TA	0.34	m
5	Vertical center of gravity	z_G	1.49	m
6	Free surface correction	ΔGM	2.58	m
7	Vertical center of gravity corrected for free surf.	$z_{G'}$	4.07	m
8	Metacentric height	GM'	5.51	m
9	Ferry list	φ	1.0	°

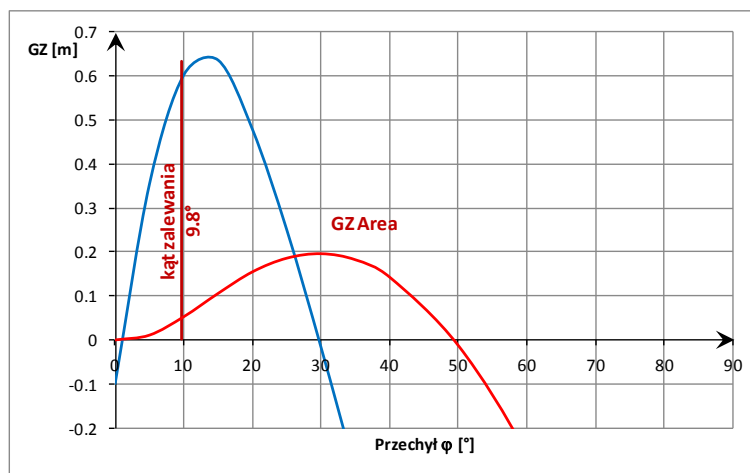
Figure 20: The diagram of righting arms

Angle of heel φ [°]	GZ [m]	Work of GZ [m·rad]
0	-0.101	0.001
5	0.353	0.012
10	0.601	0.054
15	0.634	0.107
20	0.476	0.156
25	0.247	0.187
30	-0.021	0.197
35	-0.307	0.183
40	-0.610	0.143
50	-1.180	-0.013
60	-1.690	-0.264
70	-2.141	-0.598
80	-2.528	-1.006

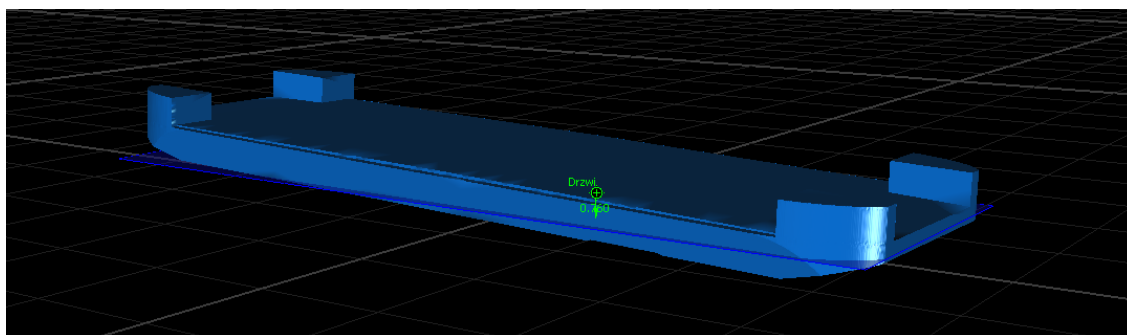
Figure 21: Position of the ferry in Condition 4/1

1	Mean draught	T	1.00	m
2	Trim	t	1.03	m
3	Draught on FP	TF	1.51	m
4	Draught on AP	TA	0.48	m
5	Vertical center of gravity	z_G	1.87	m
6	Free surface correction	ΔGM	5.24	m
7	Vertical center of gravity corrected for free surf.	$z_{G'}$	7.11	m
8	Metacentric height	GM'	3.85	m
9	Ferry list	φ	-0.8	°

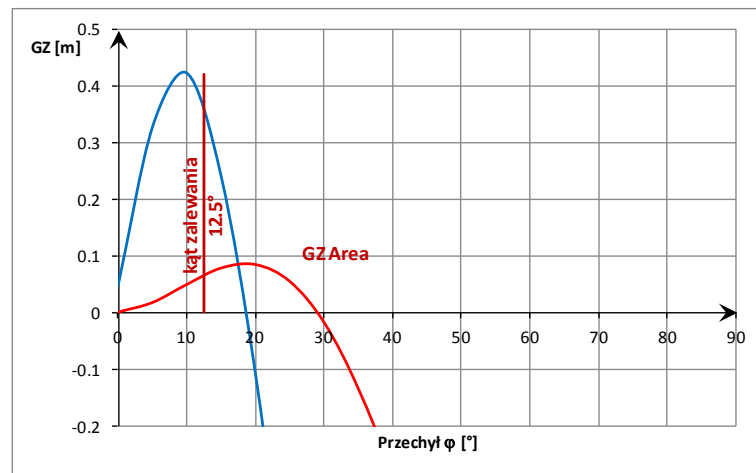
Figure 22: The diagram of righting arms

Angle of heel ϕ [°]	GZ [m]	Work of GZ [m·rad]
0	0.047	0.000
5	0.327	0.017
10	0.422	0.049
15	0.239	0.078
20	-0.111	0.084
25	-0.578	0.054
30	-1.088	-0.019
35	-1.615	-0.137
40	-2.14	-0.301
50	-3.136	-0.761
60	-4.032	-1.387
70	-4.786	-2.156
80	-5.395	-3.045

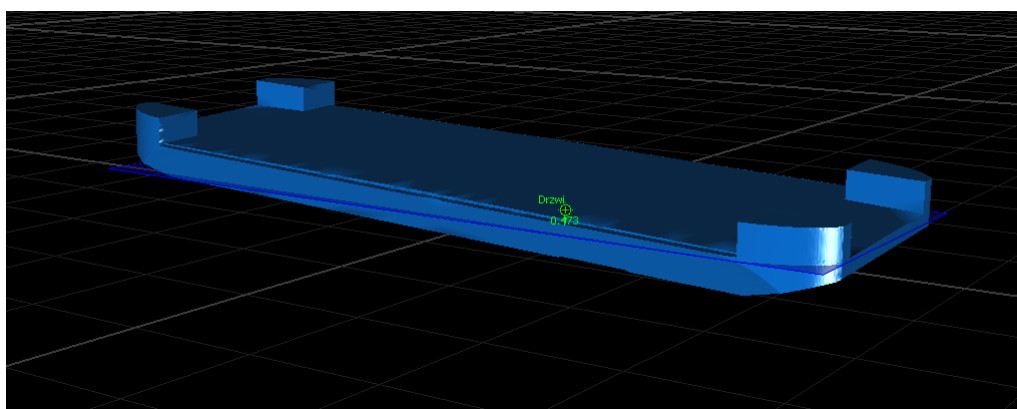
Figure 23: Position of the ferry in Condition 4/2

1	Mean draught	T	1.06	m
2	Trim	t	1.19	m
3	Draught on FP	TF	1.65	m
4	Draught on AP	TA	0.46	m
5	Vertical center of gravity	z_G	1.71	m
6	Free surface correction	ΔGM	5.09	m
7	Vertical center of gravity corrected for free surf.	$z_{G'}$	6.80	m
8	Metacentric height	GM'	2.92	m
9	Ferry list	φ	2.5	°

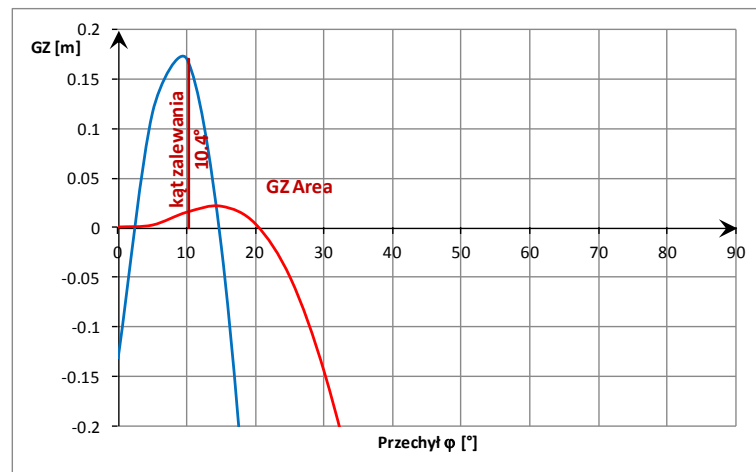
Figure 24: The diagram of righting arms

Angle of heel φ [°]	GZ [m]	Work of GZ [m·rad]
0	-0.132	0.000
5	0.116	0.002
10	0.170	0.015
15	-0.019	0.021
20	-0.406	0.003
25	-0.862	-0.052
30	-1.340	-0.149
35	-1.836	-0.287
40	-2.325	-0.469
50	-3.239	-0.954
60	-4.026	-1.588
70	-4.674	-2.347
80	-5.522	-0.577

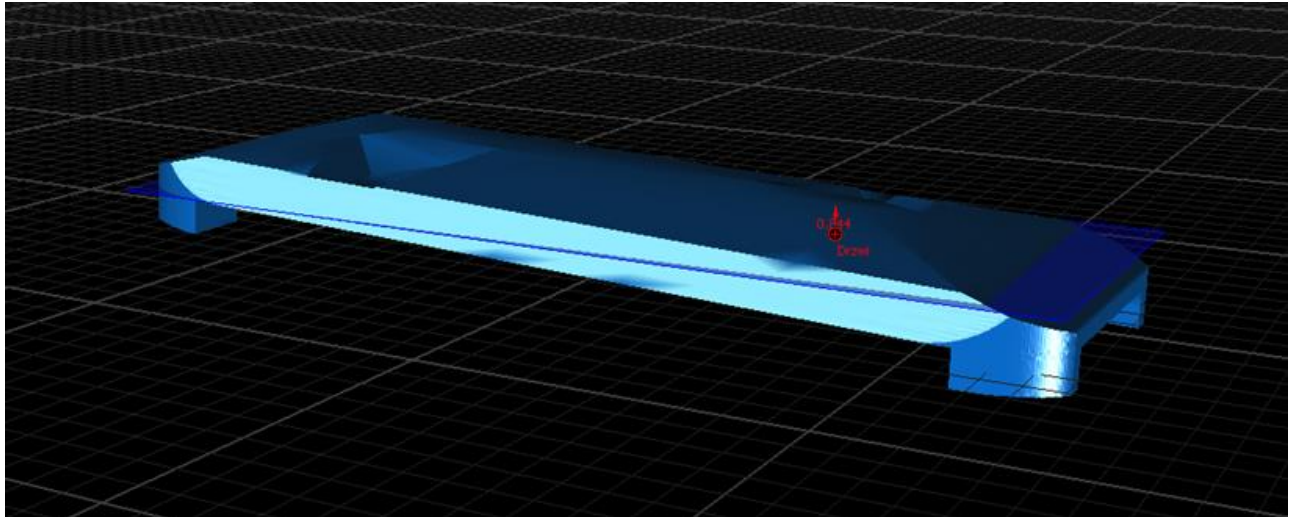
Figure 25: Position of the ferry in Condition 4/3

1	Mean draught	T	-1.30	m
2	Trim	t	1.22	m
3	Draught on FP	TF	-0.69	m
4	Draught on AP	TA	-1.91	m
5	Vertical center of gravity	z_G	1.04	m
6	Free surface correction	ΔGM	1.66	m
7	Vertical center of gravity corrected for free surf.	$z_{G'}$	5.39	m
8	Metacentric height	GM'	7.05	m
9	Ferry list	φ	6.80	m
1	Mean draught	T	179.6	°

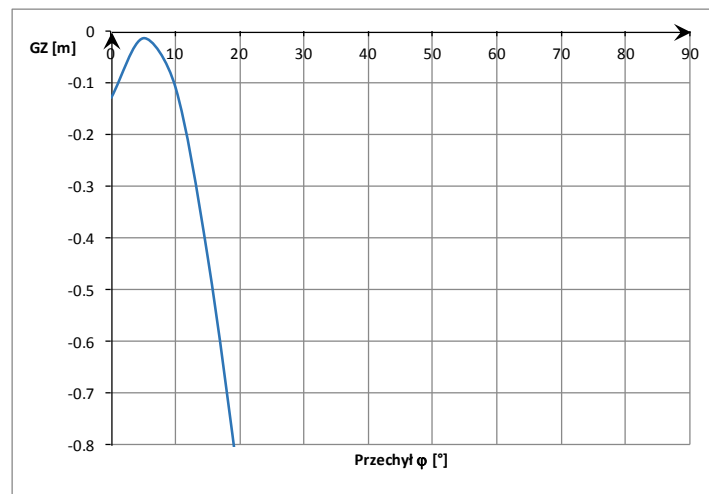
Figure 26: The diagram of righting arms

Angle of heel φ [°]	GZ [m]	Work of GZ [m·rad]
0	-0.128	0.004
5	-0.013	0.009
10	-0.109	0.057
15	-0.438	0.126
20	-0.905	0.197
25	-1.429	0.258
30	-1.979	0.301
35	-2.510	0.321
40	-2.997	0.318
50	-3.869	0.236
60	-4.560	0.055
70	-5.102	-0.219
80	-5.522	-0.577

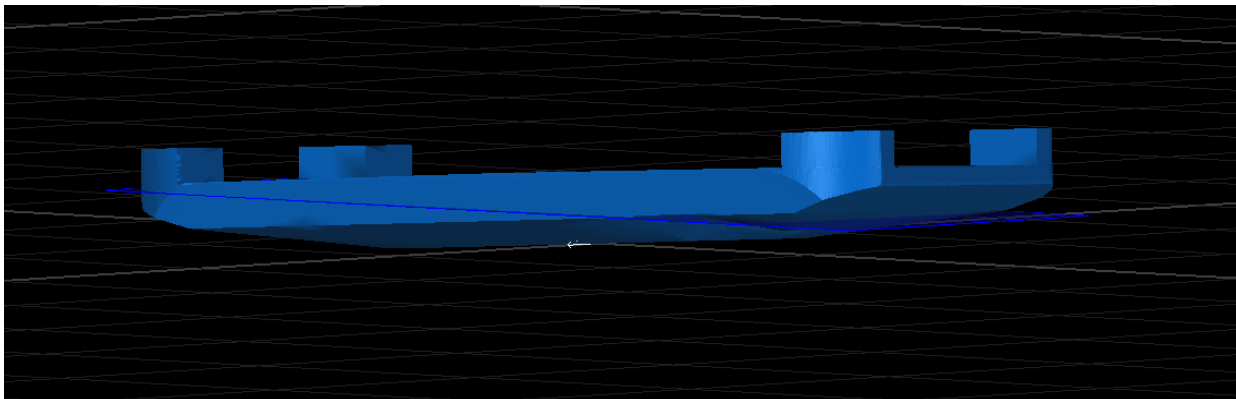
Figure 27: Simulation of the position of the ferry for the displacement of 165 t. Condition 4/3

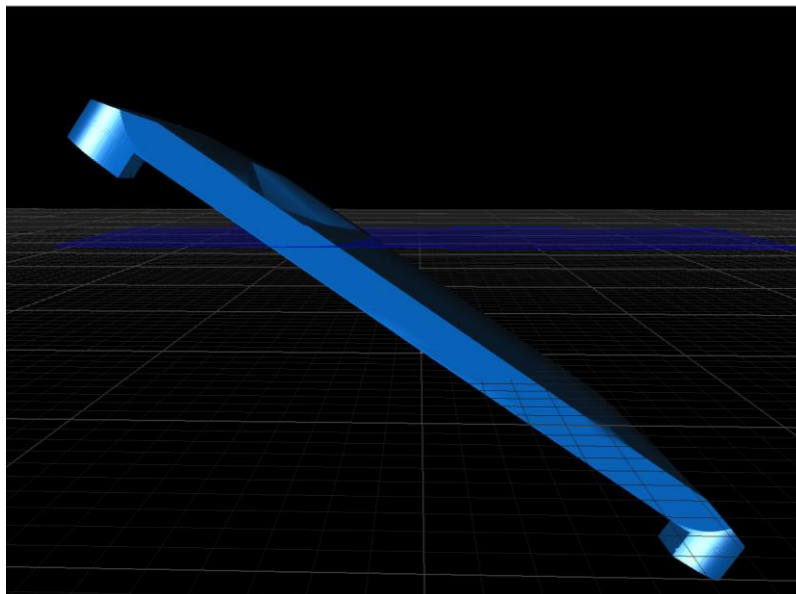
Figure 28: Simulation of the buoyancy of the capsized ferry. Displacement ca 260 t

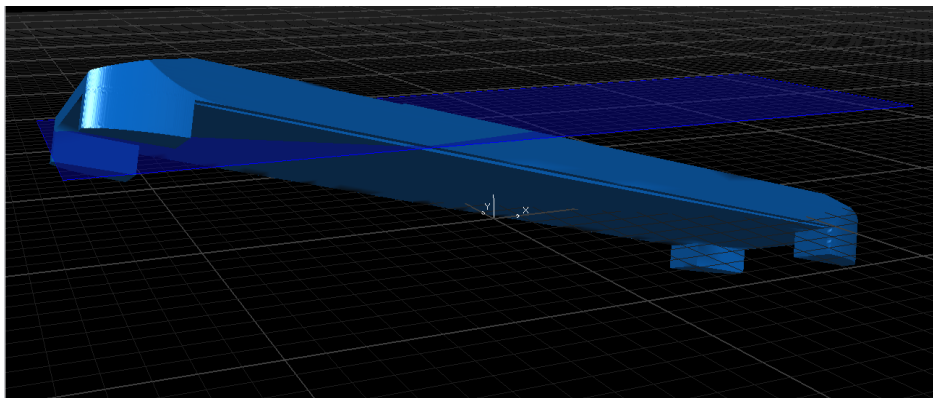
Figure 29: Simulation of the buoyancy of the capsized ferry. Displacement ca 300 t

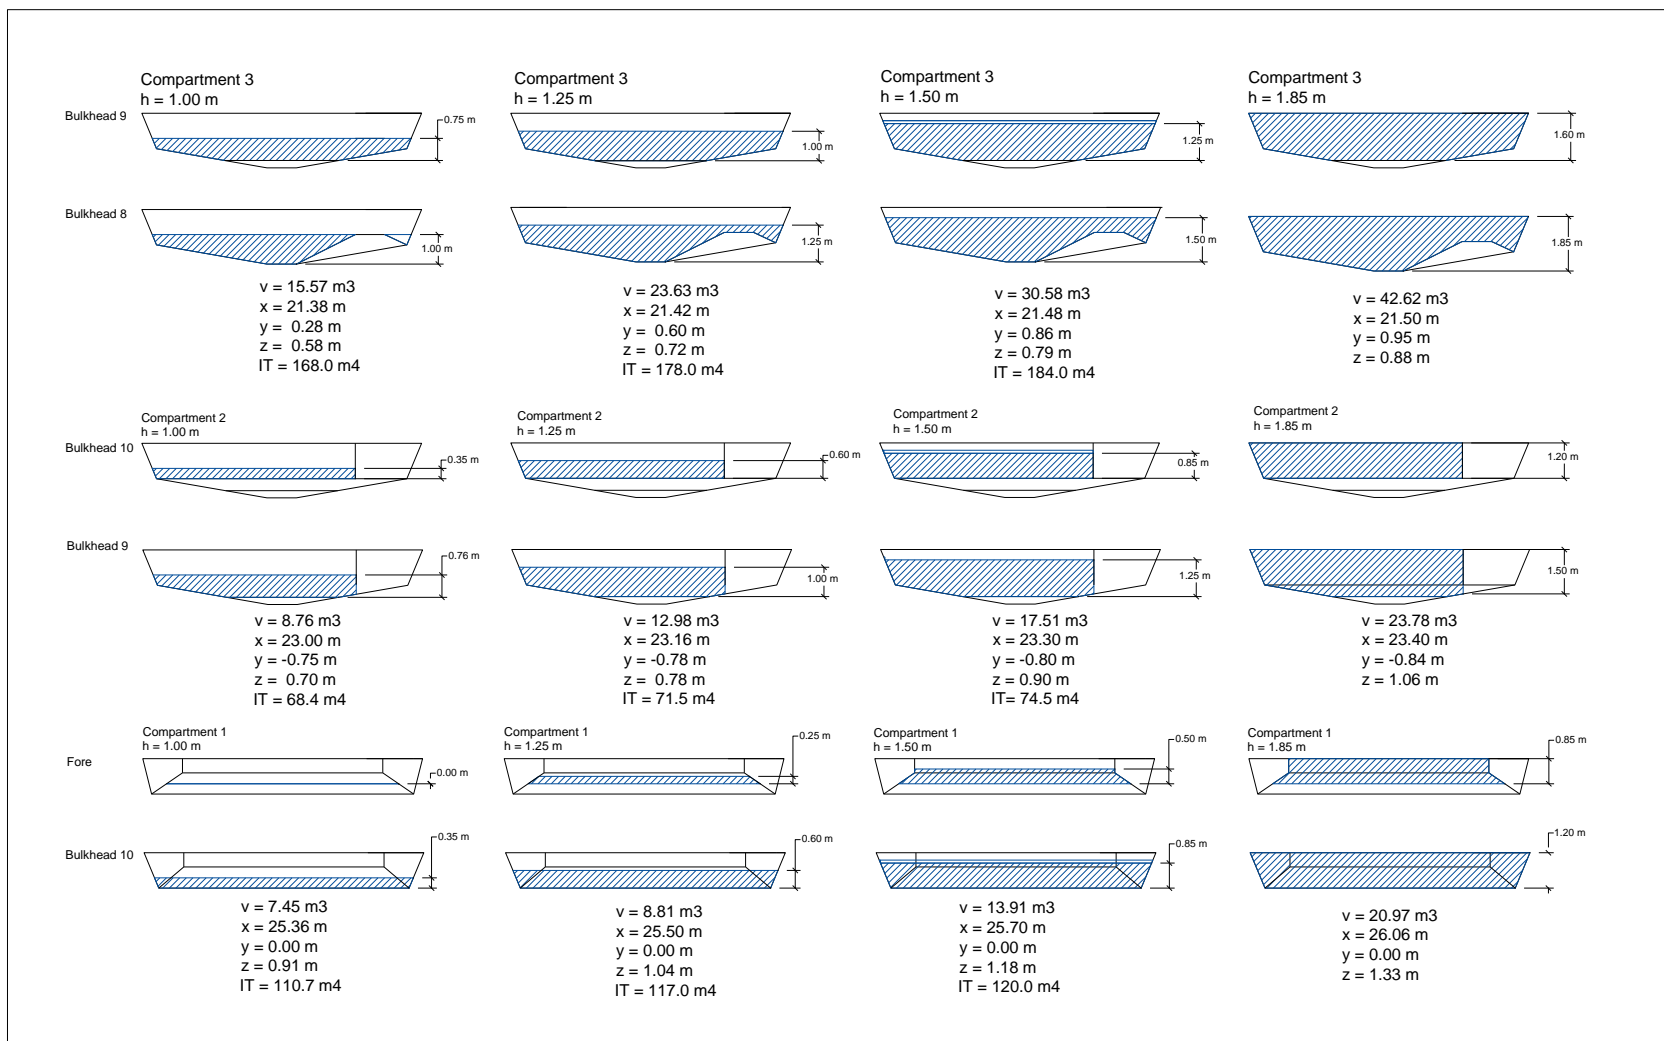
Appendix 6. Water in the watertight compartments

- **Flooding of two watertight compartments: No 1 (14.3 t) and No 3 (31.3 t) and the ingress of water on deck (33 t) causes the ferry to capsize (Condition 4/3).**
